# Hazard Mitigation Plan

THE EASTERN SHORE OF VIRGINIA

Eastern Shore Hazard Mitigation Planning Committee  
Accomack-Northampton Planning District Commission

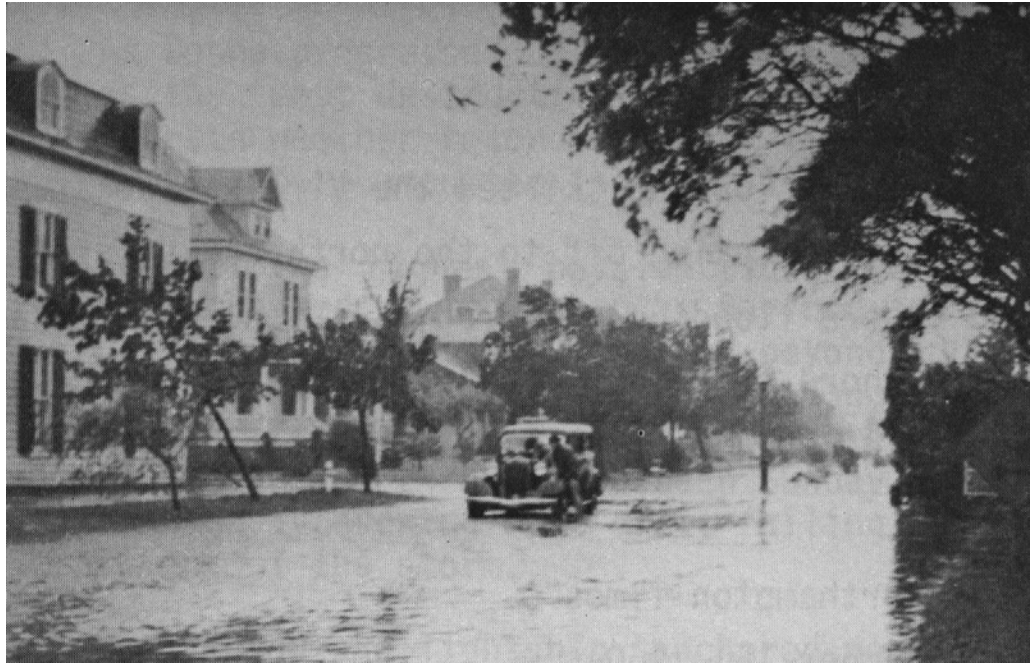
PICTURE 1.1 Flooding on Randolph Avenue, 3 ½ blocks from the Chesapeake Bay, in Cape Charles from one of the 1930s hurricanes. *Photo printed in the Army Corp of Engineers Flood Plain Report for Cape Charles*

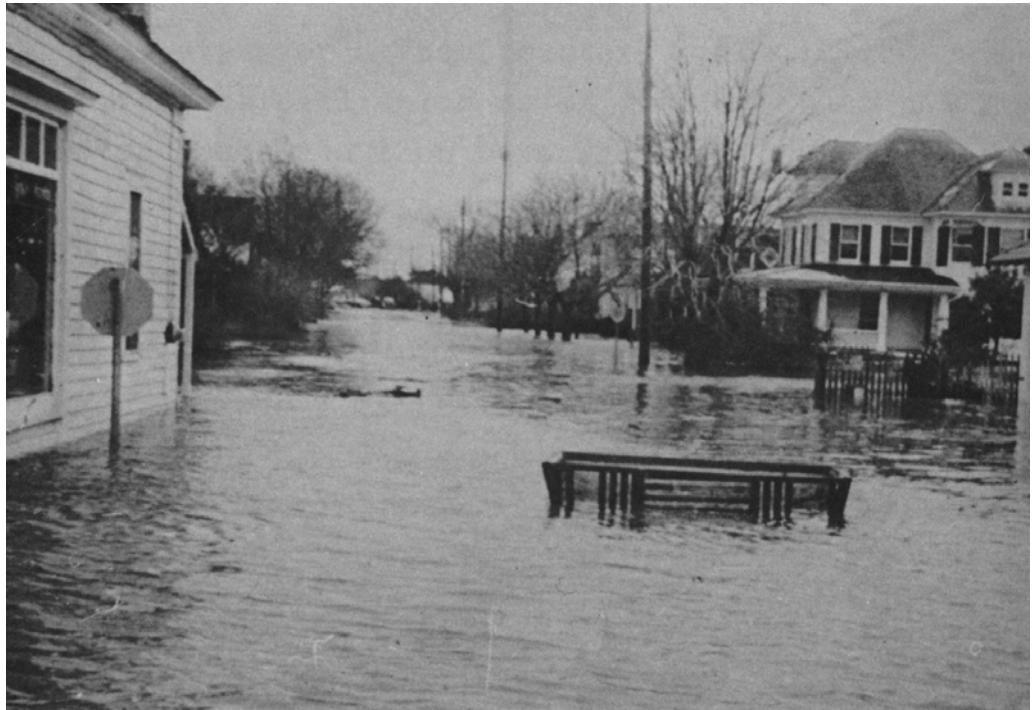
PICTURE 1.2 Flooding during the Ash Wednesday Storm of 1962. This same intersection during Hurricane Isabel is printed on page 35. *Photo printed in the Army Corp of Engineers Flood Plain Report for Wachapreague*

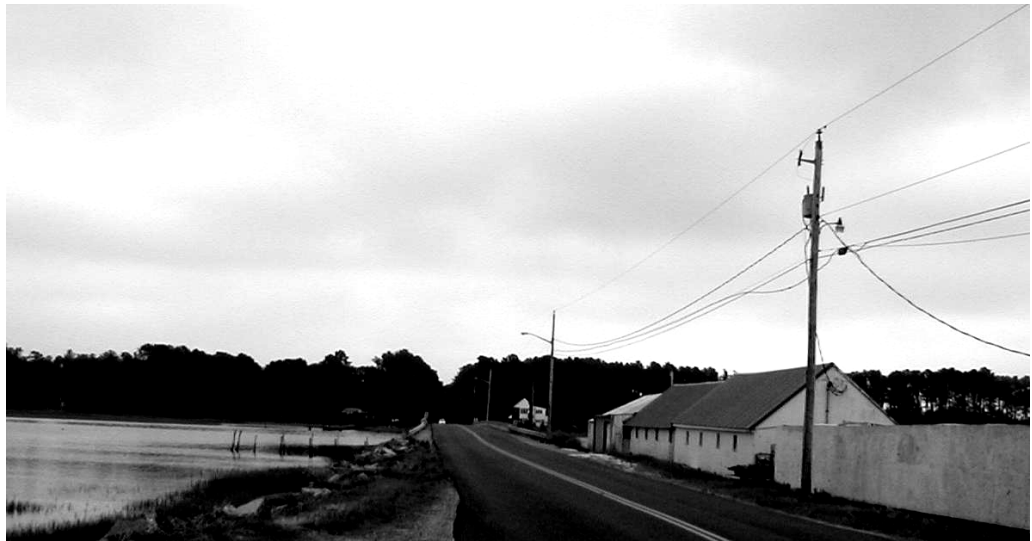
PICTURE 4.1 Causeway to Quinby during spring tide. *Photo by Elaine Meil*

these numbers that a moderate storm surge occurring with a perigean spring tide and at high tide could cause severe damage while a high storm surge occurring with an apogean neap tide and at low tide could cause low or moderate damage. On the bayside, the magnitudes of the differences are lower but the same effect can still be seen. Onancock on the bayside has a difference of 3.1 feet from the lowest tide to the highest tide in 2004. The average daily change in tides there is 2.0 feet. (Center for Operational Oceanographic Products and Services, NOAA)

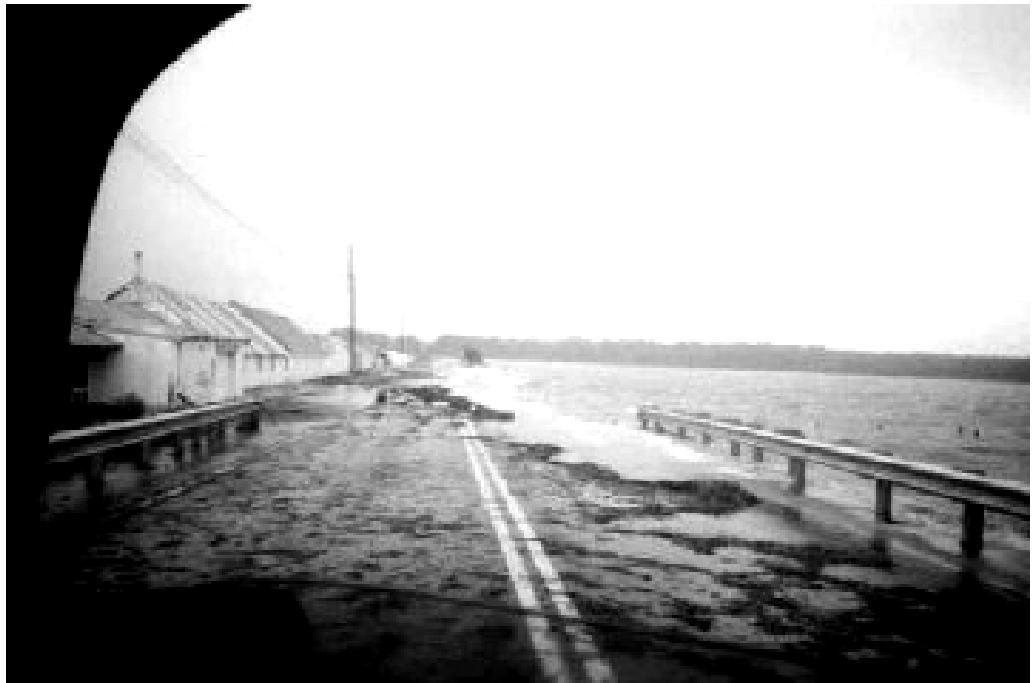
PICTURE 4.2 Causeway to Quinby during Hurricane Isabel. *Photo by David Fluhart*

The Base Flood Elevation (BFE) on the seaside of the Eastern Shore is 11 to 13 feet and on the bayside the BFE is usually 7 to 10 feet. The BFE is the elevation of water in the 1% probability base flood event also known as the 100-year event. This BFE is consistent with a Category 2 hurricane or Category 3 hurricane's surge. However, due to the geometry of the Bay a Category 1 hurricane or a tropical storm can cause this amount of surge.

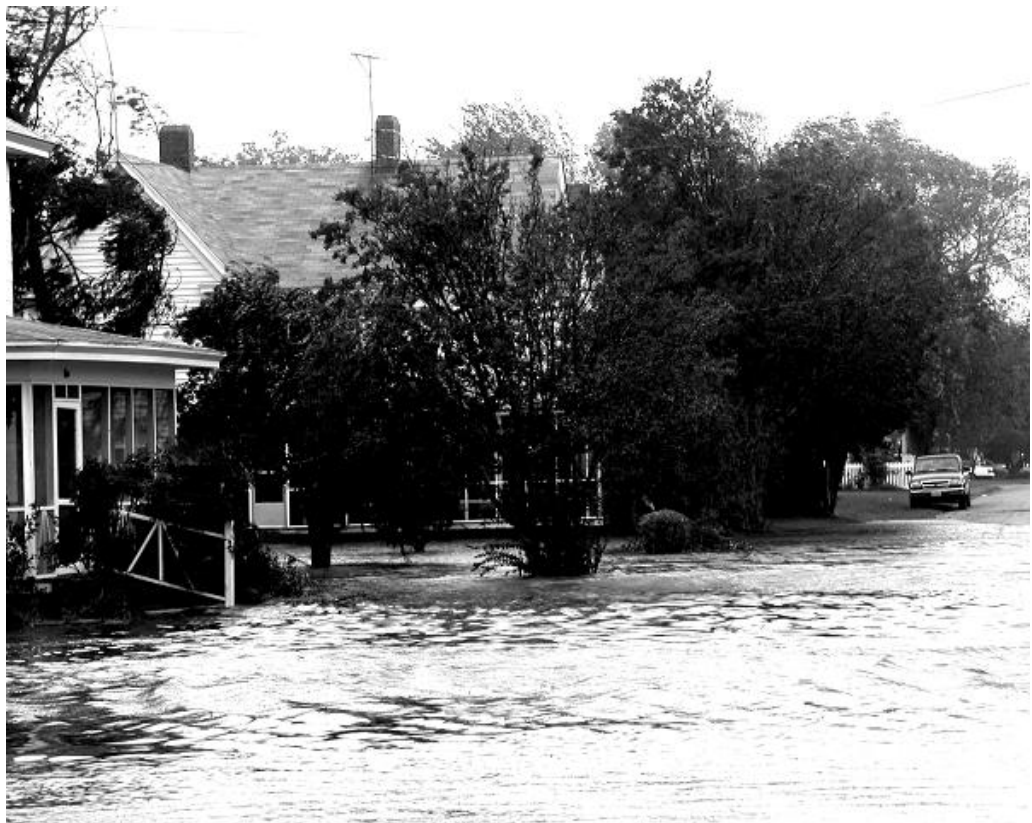
PICTURE 4.3 Homes in Wachapreague during Hurricane Isabel. These homes are located in an A zone with a Base Flood Elevation that includes a wave height component.  
*Photo by John Aigner*

Coastal A zones also represent increased vulnerability to both Accomack and Northampton County. The NFIP does not recognize the difference between A zones where the source of water is an inland river or an A zone where the source of water is from a bay or ocean. Therefore, the NFIP regulations do not require special construction for coastal A zones. However, structures in these zones are commonly exposed to weaker V zone conditions including waves, scour and velocity flows. Open foundations are not required in these areas. However, waves and debris can still destroy structures there. If a structure is built with a closed foundation that structure can expect to receive more damage if struck with storm surge water than a similar structure with an open foundation.

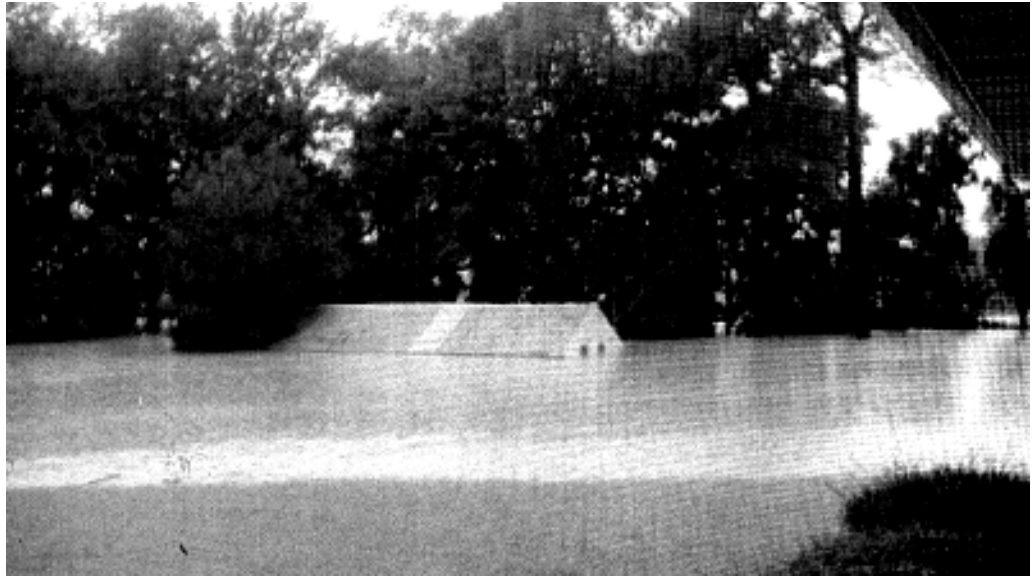
PICTURE 5.1 A structure in the Town of Bloxom on September 3, 2004 the trees in the distance line the railroad. *Photo by Franklin Kreisl*

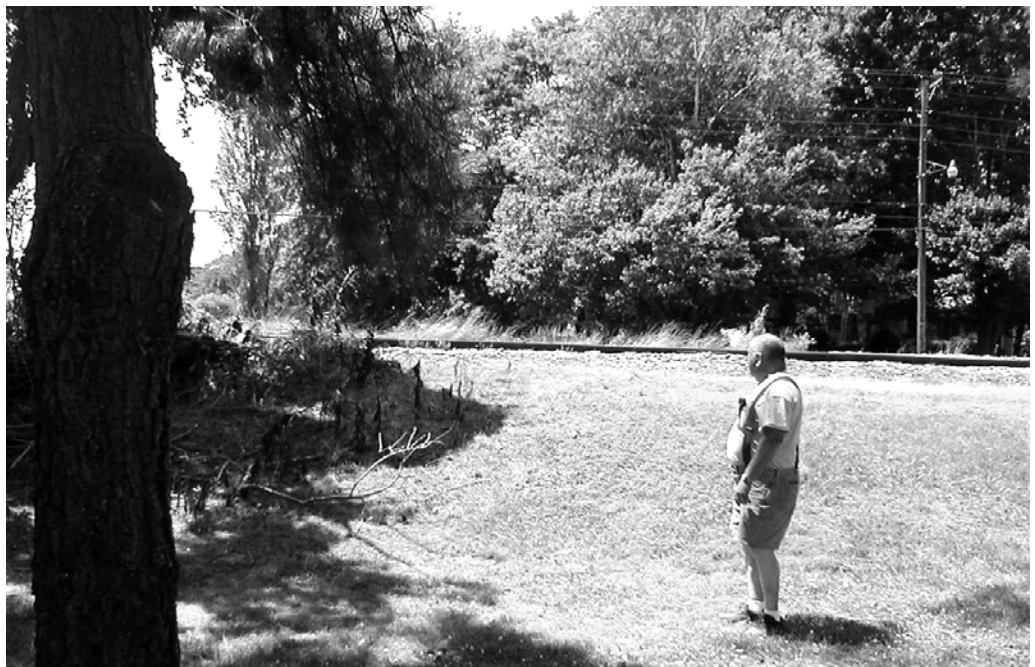
PICTURE 5.2 Area where the floodwater was dammed against the railroad tracks. The pine in this picture is the same as the lone pine in the previous photo of the flooding. *Photo by Elaine Meil*

In addition, high tide was in and the water could not drain away. The drainage ditch was also scheduled for maintenance but Accomack officials believe that had the maintenance been done it still wouldn't have stopped the areas from flooding. In Bloxom, floodwaters reached a depth of at least 2 feet. In some areas the flooding was greater.

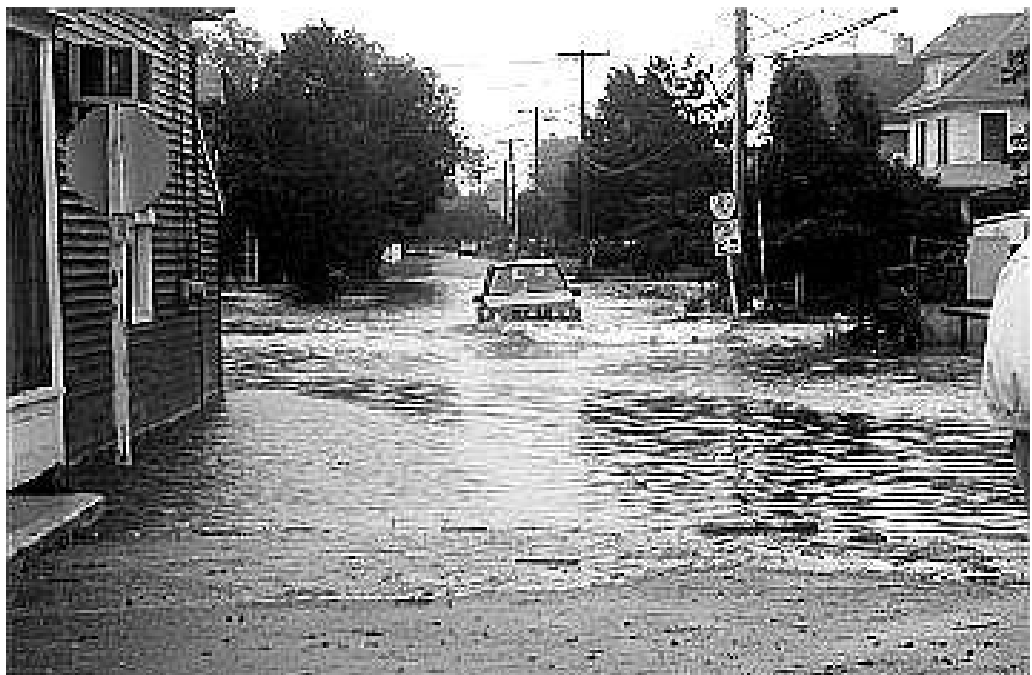
PICTURE 5.3 Car fording street flooded by surge from Hurricane Isabel. *Photo by David Fluhart*

Storm water floods that move faster than 10 ft per second are generating hydrodynamic loads in addition to the hydrostatic loads. These loads can destroy walls, push structures off of foundations, and carry sediment and debris. (Coastal Construction Manual, FEMA)

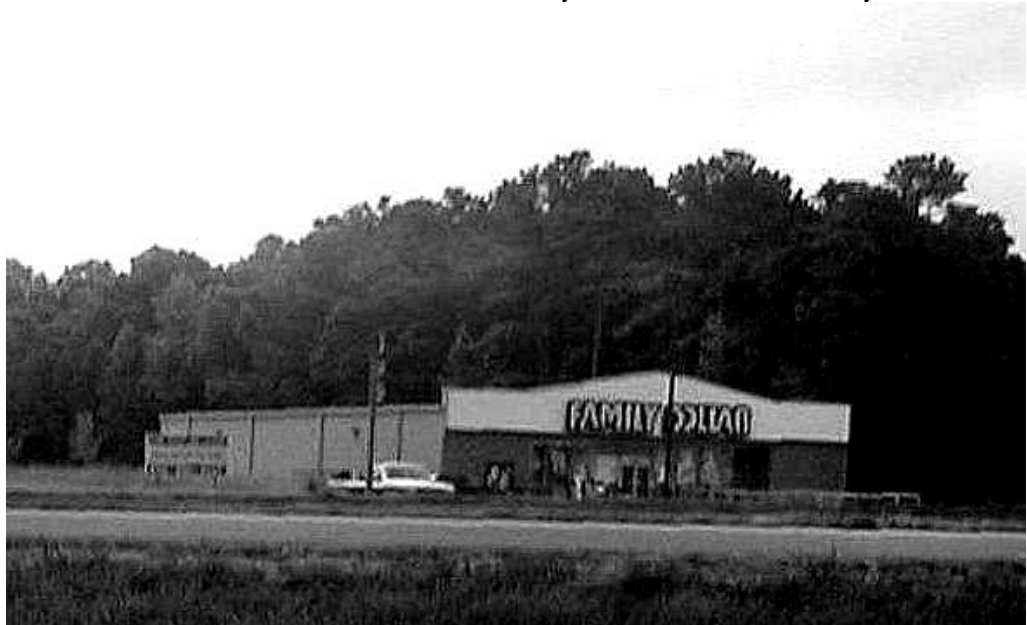
**PICTURE 8.1** This building and its parking lot in the Town of Onley frequently is flooded by storm water. As can be seen from the truck in the picture this building was built in a substantial depression. Just visible in the photo is the platform for customers to access the store after a rain. The lot next door, also located in the depression, is for sale. *Photo by Elaine Meil*

Local officials identified various areas in the county that have storm water flooding problems. These areas include the intersection of Route 13 and Route 175 in New Church, Horntown Road east of Route 13, Neil Parker Road in Sanford, parts of the Town of Hallwood, parts of the villages of Pastoria and Mappsville, the low lying lands south from Messongo to Chesconnessex, parts of the town of Accomac, Bayside Road between Shields and Craddockville and the Family Dollar store in Onley.

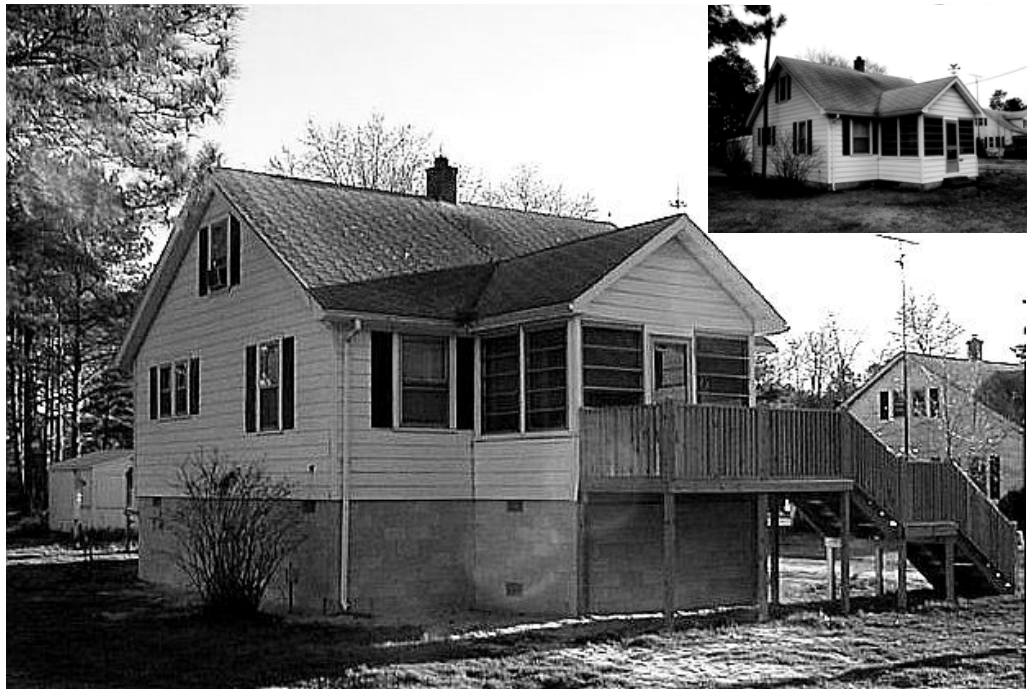
PICTURE 8.2 The county elevated this home using Hazard Mitigation Grant Program money. *Photos by David Fluhart*

**HMGP Participation.** The County of Accomack has participated in the Hazard Mitigation Grant Program in the past. After Hurricane Floyd in 1999, the county received a 28 home elevation project. Those homes that were elevated were located in the unincorporated portions of the county and the Town of Tangier. After Hurricane Isabel, Accomack County submitted a HMGP application to elevate another 20 homes.

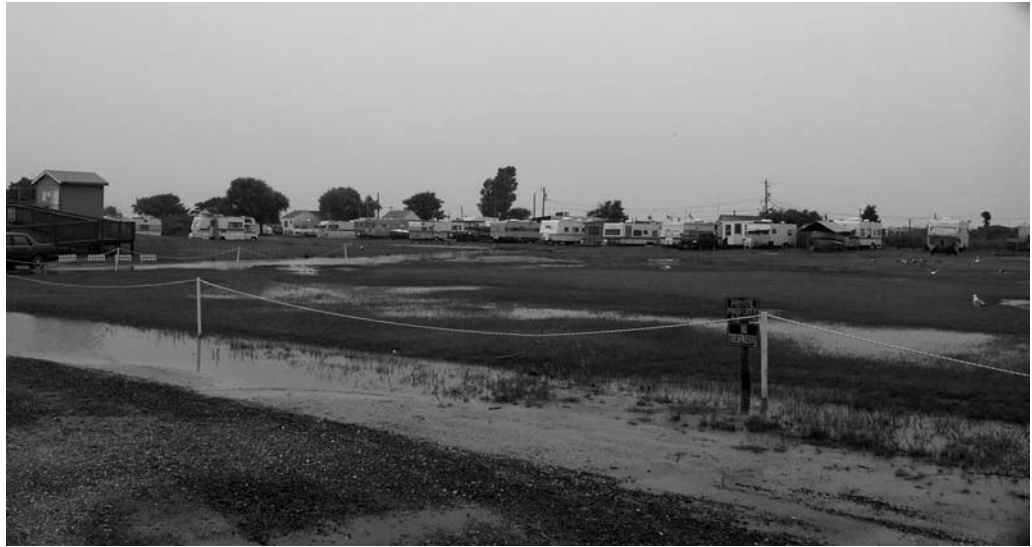
PICTURE 9.2 Mobile Home Park on the southern tip of Chincoteague Island. *Photo by Elaine Meil*

**High Wind Events.** ASCE 7-98 defines the Wind Borne Debris Hazard Area as within 1 mile of the coast where basic wind speed is equal to or greater than 110 mph (3 sec gust). Chincoteague is within the 110-120 mph range. The coast of Assateague Island and Wallops Island generally are further than 1 mile from Chincoteague. The southern tip of Chincoteague is the only place that falls near or within this zone. There are two mobile home parks in this area. There are approximately 180 units in the park most threatened worth approximately \$6.8 million. Assuming, a 110 mph (3 sec gust) event, which is the 100-year event in hurricane prone areas, Chincoteague could expect that most of these mobile homes would be a complete loss.

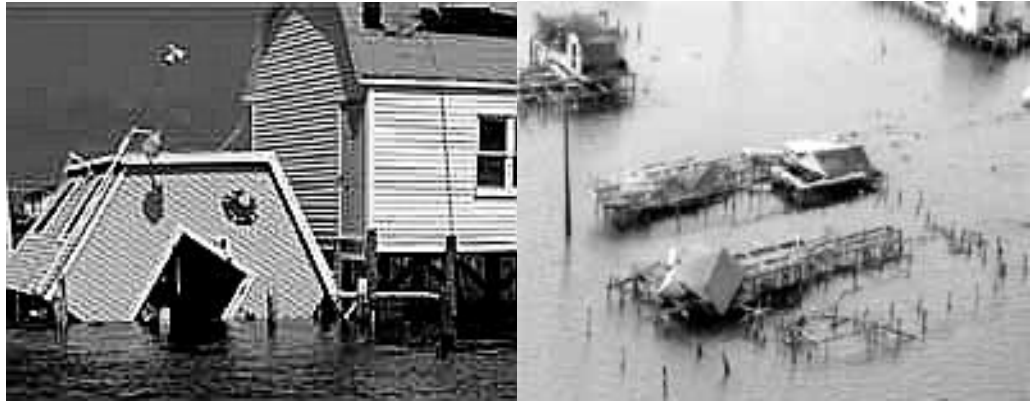
PICTURE 11.1 Crab houses on Tangier damaged during Hurricane Isabel. *Left Photo by George Roarty, Right Photo by Chesapeake Fire Department*

Hurricane Isabel, although not reaching the Base Flood Elevation, almost wiped out the crabbing industry on Tangier. Some crab houses were completely washed away while other listed into the water. Approximately 34 crab houses, 40%, were destroyed or significantly damaged of an approximate 85 crab houses. These crab houses were located in the southeast of Mailboat Harbor. This was the area where the winds and surge were coming from. Since these buildings are over water they are not eligible for NFIP flood insurance. These crab houses cost approximately \$25-\$30 per square foot to rebuild. Commonly, crab houses run 12 x 12 to 16 x 20. Other watermen sustained losses when their crab pots and crab floats were washed away. These were not insignificant losses since one float costs approximately \$100 and a crab pot runs about \$20-\$25. A waterman may have 700 crab pots and 30 floats. Each of these crab-processing businesses generates annual sales of \$18,000 to \$25,000. Crab season runs from April to November with much of the harvest time corresponding to hurricane season.

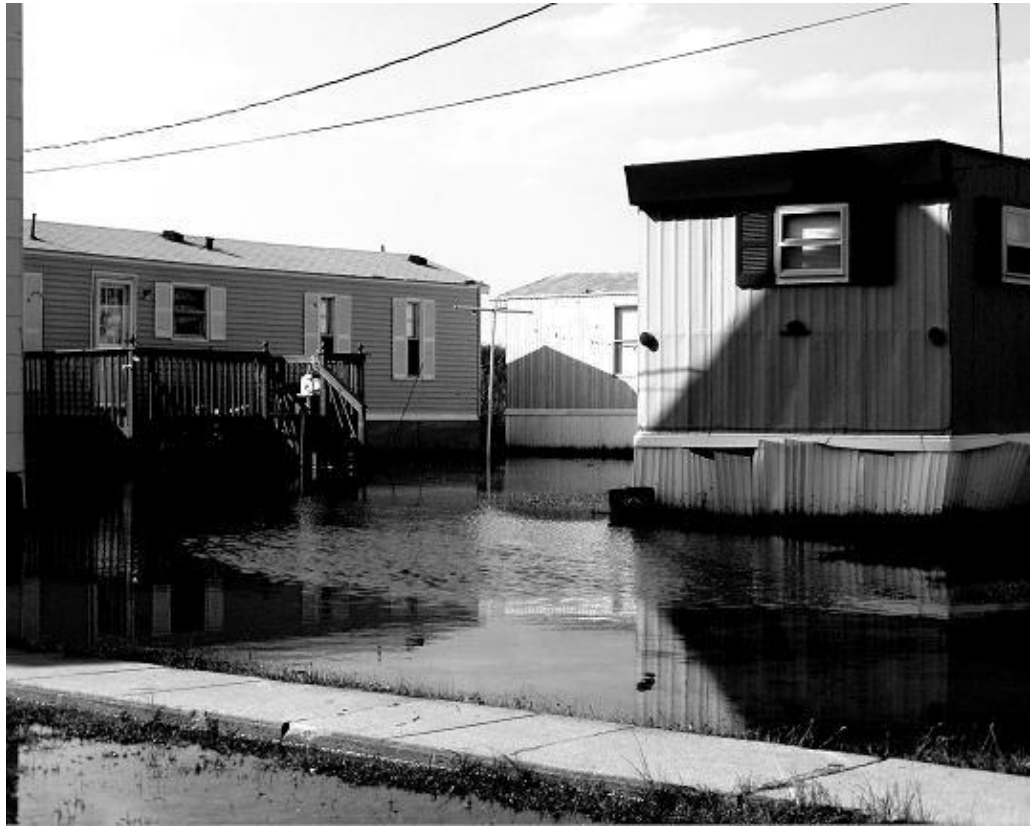
PICTURE 11.2 Flood water ponding around homes on Tangier after Hurricane Isabel.  
*Photo by Deborah Mills*

The island is susceptible to poor drainage due to high water and has localized ponding after storms. Currently, there is no stormwater management on Tangier (Tangier Town Plan, 2001). In particular, stormwater carries pollutants into the wetlands and damages the nurseries of marine life that the town's economy depends on.

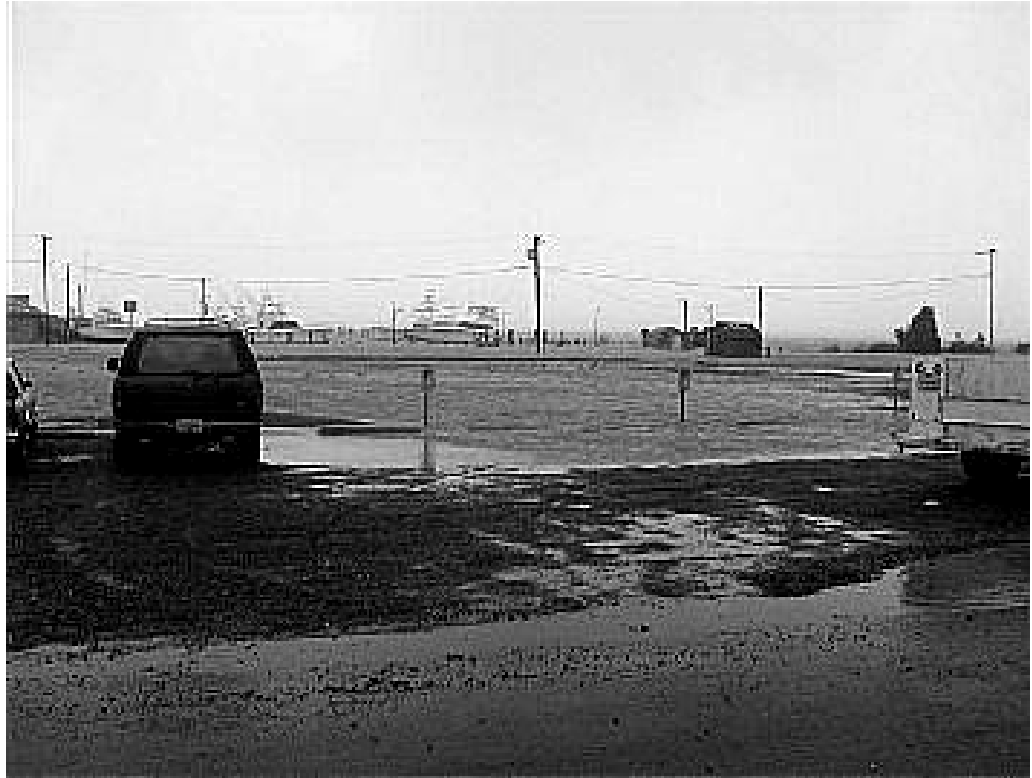
PICTURE 12.1 Surge during Hurricane Isabel taken from the Wachapreague Fire Department. *Photo by David Fluhart*

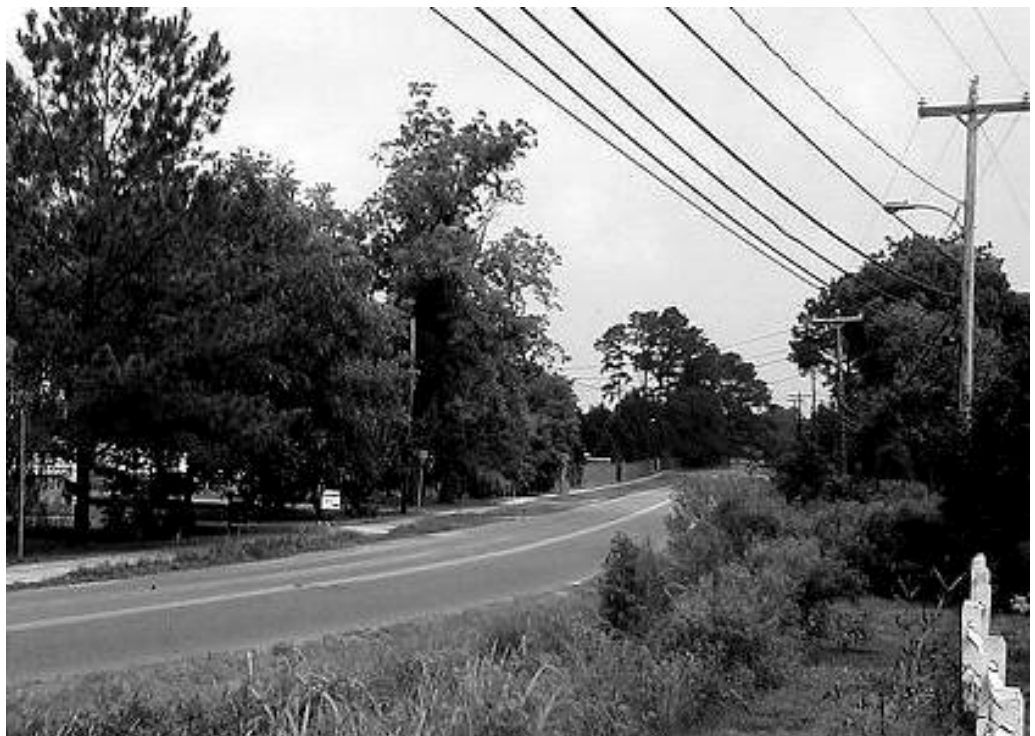
**PICTURE 13.1** The fence in the distance is the Onancock Wastewater Treatment Plant. The home to the side of the picture has recently been elevated to the Base Flood Elevation.  
*Photo by Elaine Meil*
